Manhole Inspection Summary

Manhole # S31I__020MH

Insp Date: **11/12/08 11:13 AM**

Location Address: **401 w. pratt st**

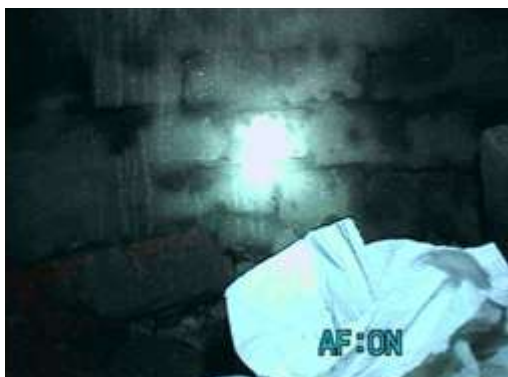
Defect 5

Infiltration: ☐ None ☐ Joint ☐ Cracks ☐ Mortar ☐ Roots ☒ **Wall**

Condition: ☐ Sound ☐ Cracked ☐ Root Intrusion ☐ Deteriorated ☐ Leaks ☒ **Debris**

signs of barrel infiltration, channel debris

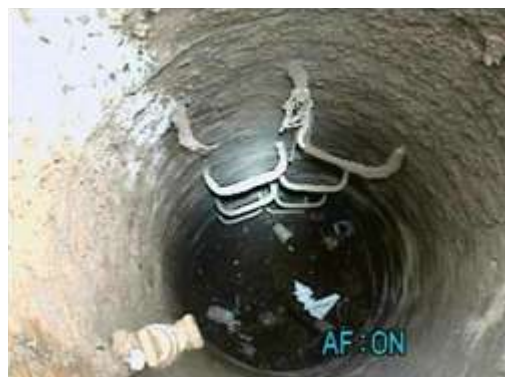
Defect 4

Count: **8** Missing: **1** ☒ **Corroded**

cor. steps

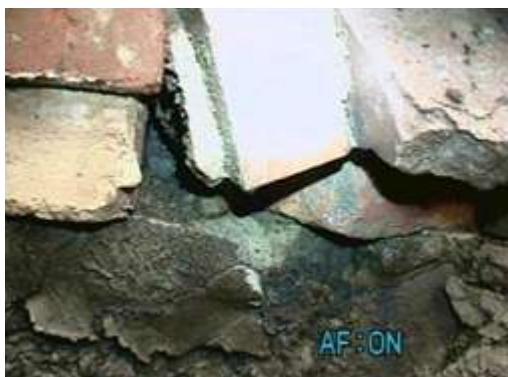
Defect 3

Condition: ☐ Sound ☒ **Cracked** ☐ Root Intrusion ☒ **Loose Brick** ☒ **Deteriorated**

Infiltration: ☐ None ☒ **Joint** ☐ Cracks ☐ Mortar ☐ Roots ☐ Wall

chimney loose bricks and deteriorated, infiltration, frame adj

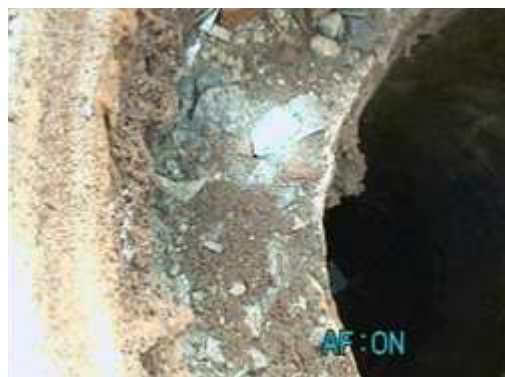
Defect 2

Offset: **6** (in.)

offset

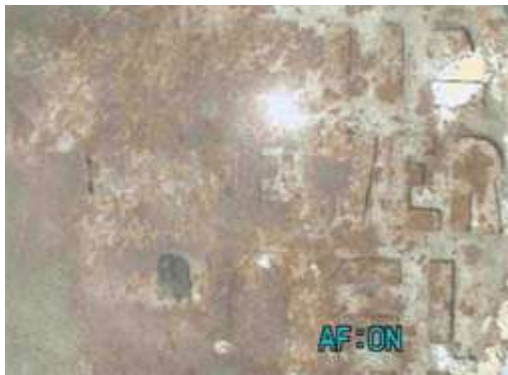
Defect 1

Condition: **Worn**

WORN COVER

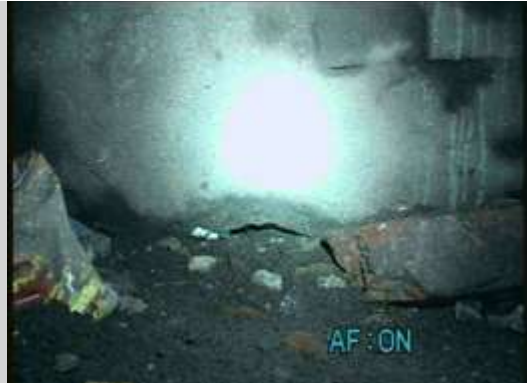
12 O'Clock Outflow

Deposits: ☐ None ☐ Mud ☐ Sludge ☒ **Debris** ☐ Grease

Silt Depth: **8** (in.) Deposits Extent: **Heavy**
